**STUDY SUMMARY – WHITE PAPER**

**January 12, 2023**

**MD 97 (Georgia Avenue) High Injury Network Safety Study  
Recommendations Specific to Montgomery County DOT**

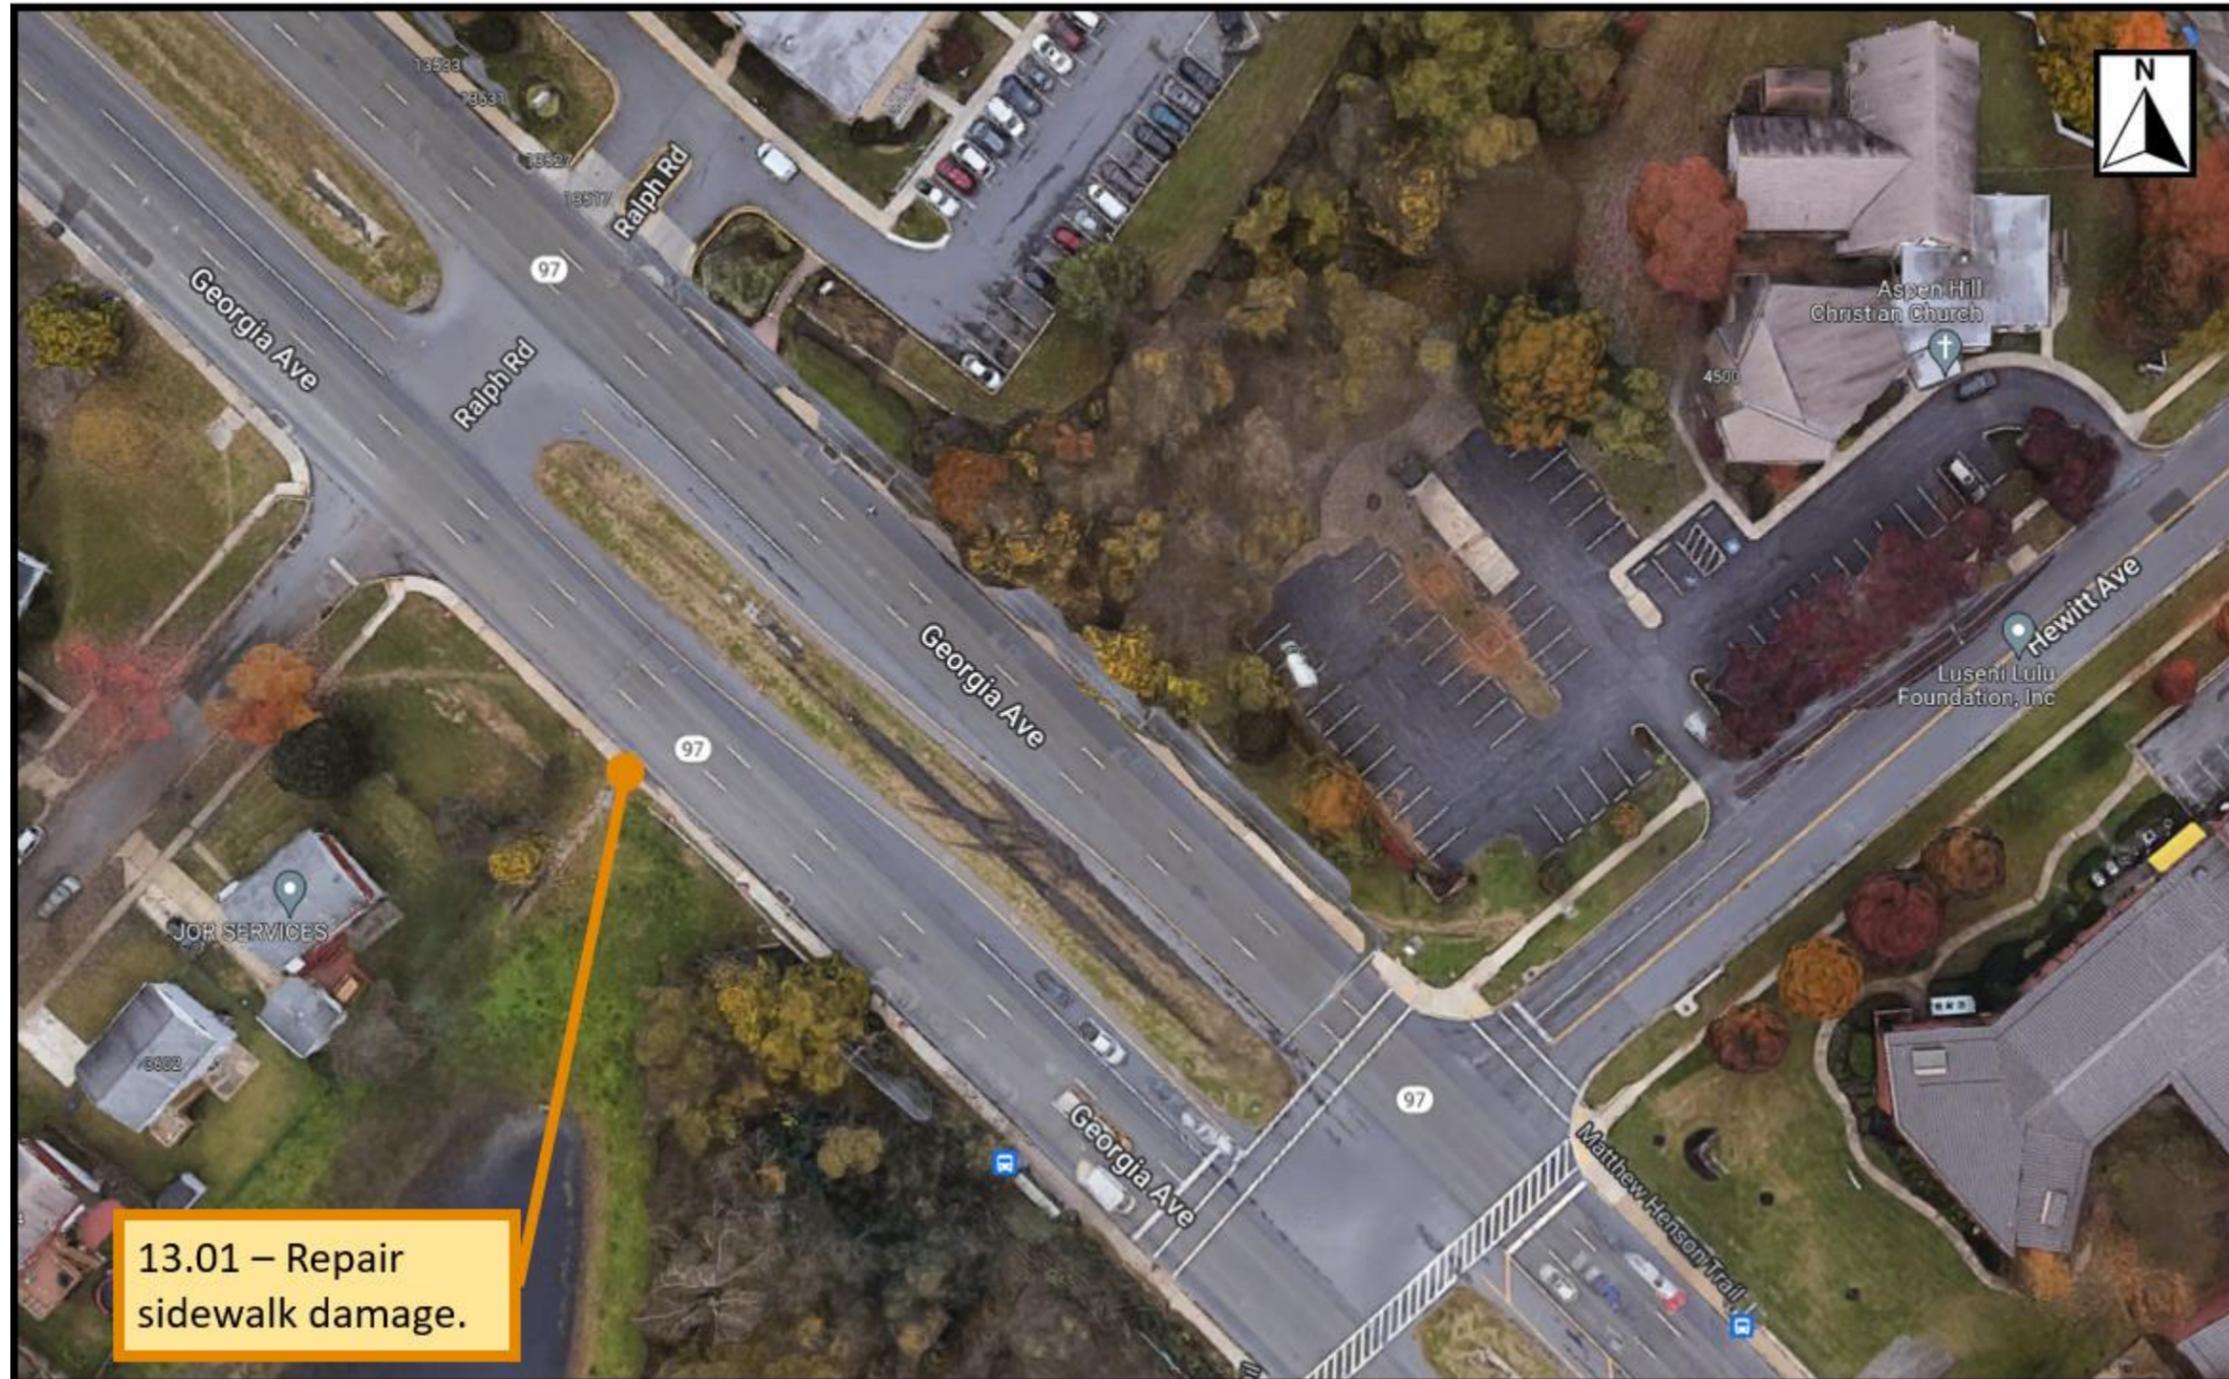
Figure 9: MCDOT – Specific Recommendations: MD 97 (Georgia Avenue) between Ralph Road and Hewitt Avenue

13.01	Maintenance. Sidewalk and driveway apron damaged and collecting sediment.	Repair the sidewalk damage along SB MD 97 at the maintenance driveway apron.	0 – 6 months

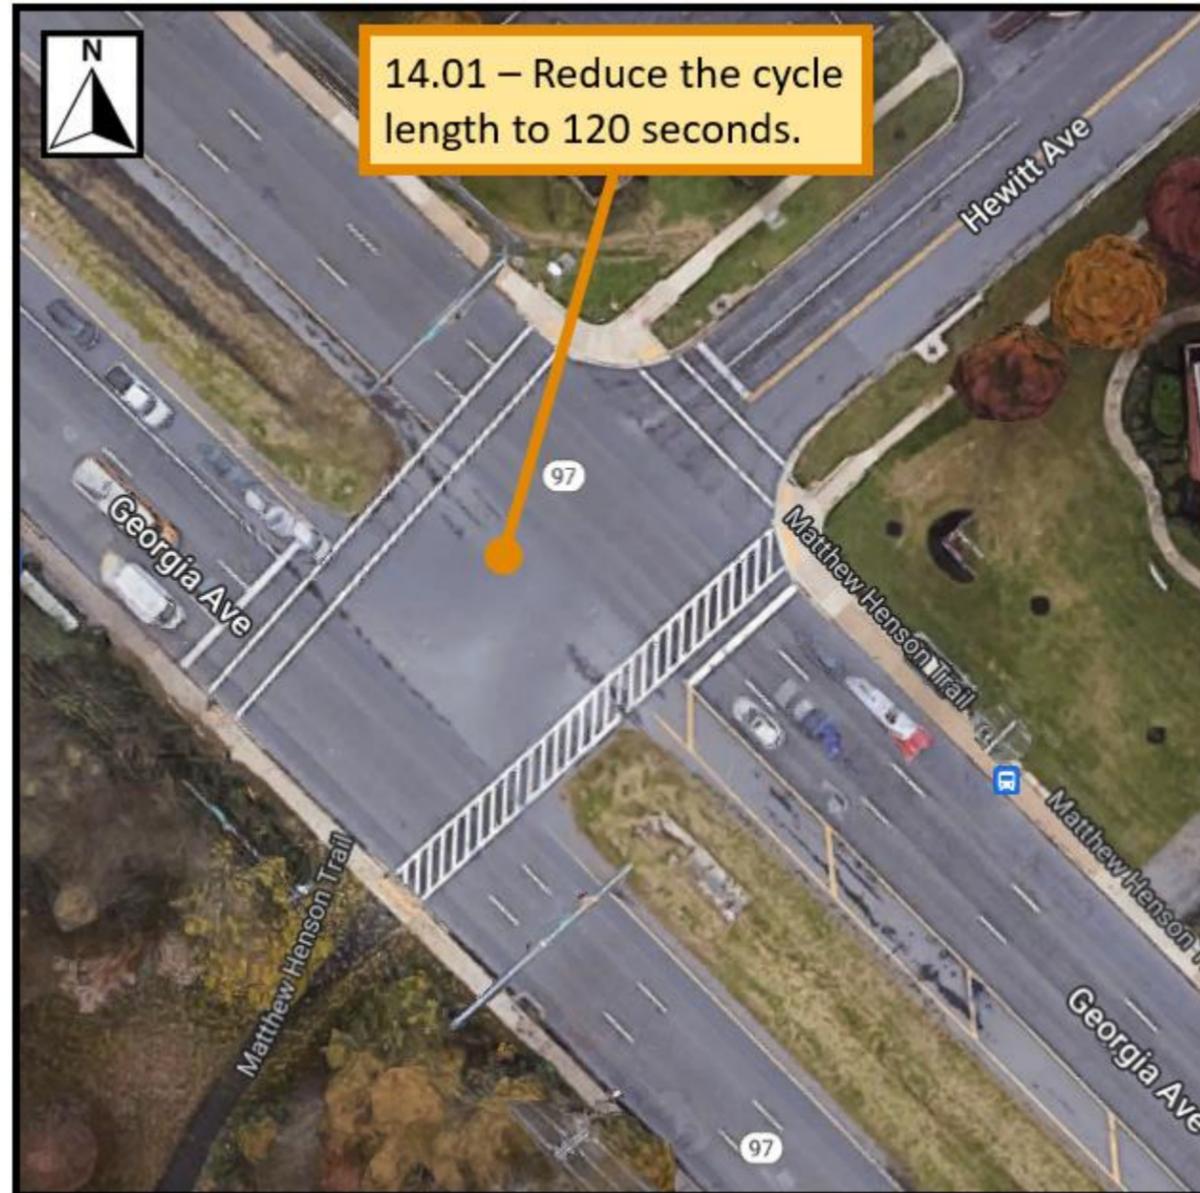
Figure 10: MCDOT – Specific Recommendations: MD 97 (Georgia Avenue) at Hewitt Avenue

Issue No.	Safety Issue/Observations	Recommendation	Timeframe
Location 14: MD 97 (Georgia Avenue) at Hewitt Avenue – Signalized Intersection			
14.04	Ped Facility Limitations. Frequent vulnerable road user activity at intersection due to transit stops and trail access.	Reduce the signal cycle length to 120 seconds.	0 – 12 months
Location 00: Corridor-Wide			
00.11	Traffic Operations	Modify traffic signal timing offsets and signal timing schedule optimizations at all intersections.	0 – 6 months
